(BDIZ EDI) Implant-Study 2014/2015

Quantitative and qualitative element-analysis of implant-surfaces by SEM and EDX

PRELIMINARY STUDY RESULT

C-P1 - LOT 13M0032D78C65A65581
C-P7 - LOT 12P0764D75C61A61S77

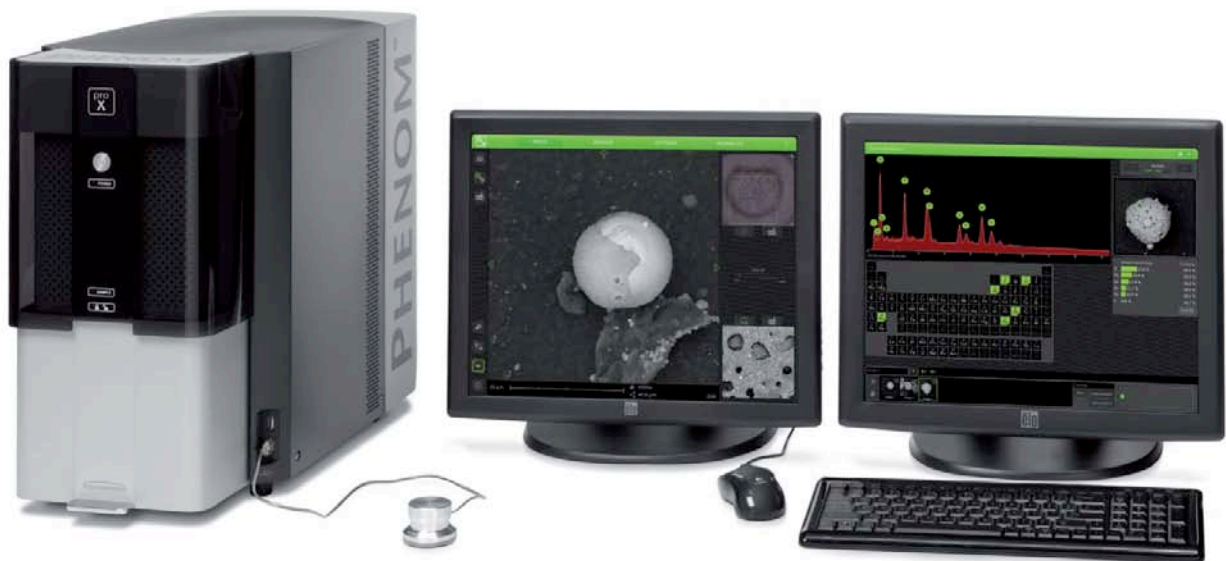
The scientific workstation is a Phenom proX Scanning Electron Microscope, equipped with a high-sensitivity backscattered electron detector that allows compositional and topographical imaging modes. EDX analyses are performed with a thermoelectrically cooled Silicon Drift Detector (SDD).

Workstation with Phenom proX Scanning Electron Microscope

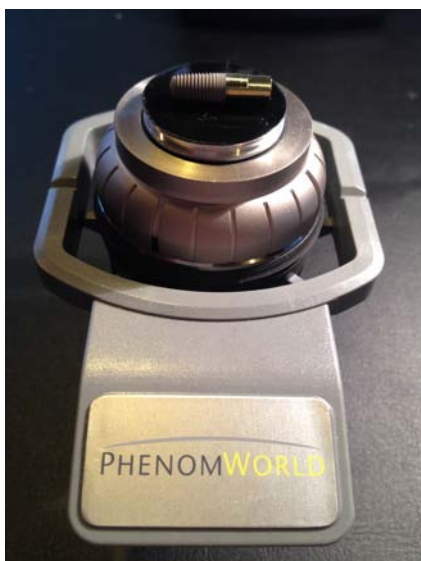
Without touching the surface, each implant will be taken out of the package with sterile forceps and will be fixed on the sample holders. After the vacuum is generated in the electron microscope imaging and EDX-analyses will be completed.

Fixed implant (example) on the sample holder
